PI Home & Property Inspections

May 16th 2023, 6:01 pm

BUILDING ADDRESS: 123 Sample St.

INSPECTION DESCRIPTION: Residential

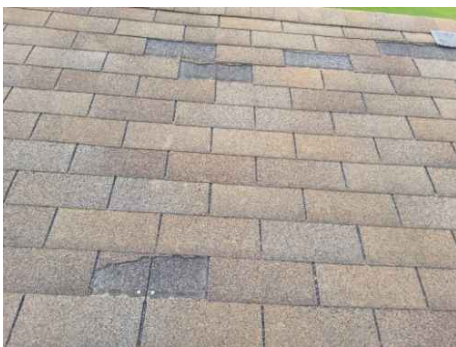
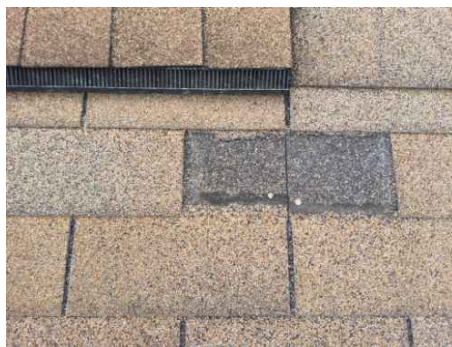
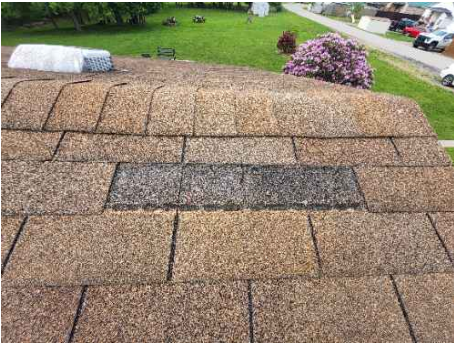
SHINGLES MISSING / DAMAGED? Poor

On the day of inspection it was observed numerous shingles missing from the roof covering leaving exposed nails which will potentially allow moisture penetration into the roof structure. Recommend further evaluation and correction by licensed roofing contractor.

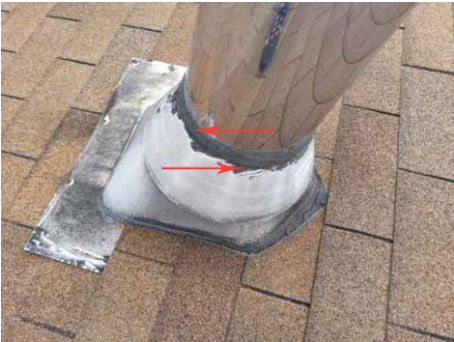
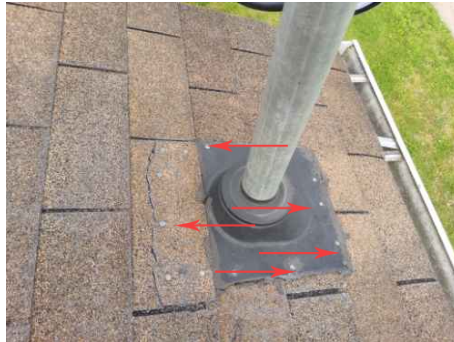
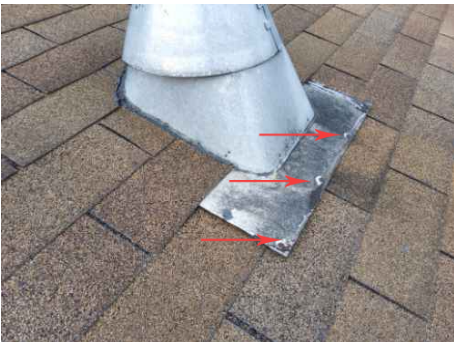
FLASHING Poor

On the day of inspection it was observed multiple locations of exposed nails are in the flashing which could lead to moisture penetration in those areas. Also chaulk around heating vent pipe is cracked and is in need of replacement. Recommend further evaluation and correction by a licensed roofing contractor.

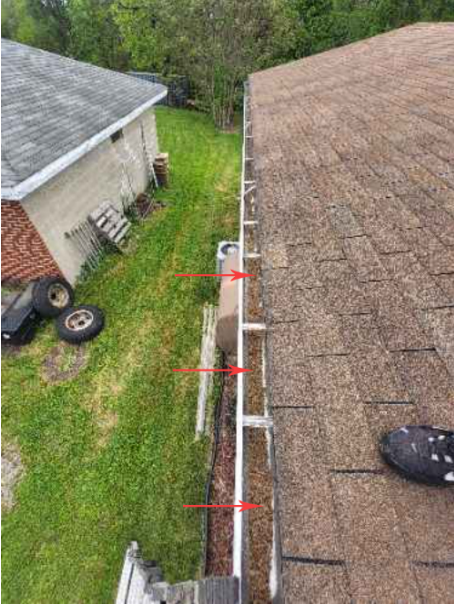
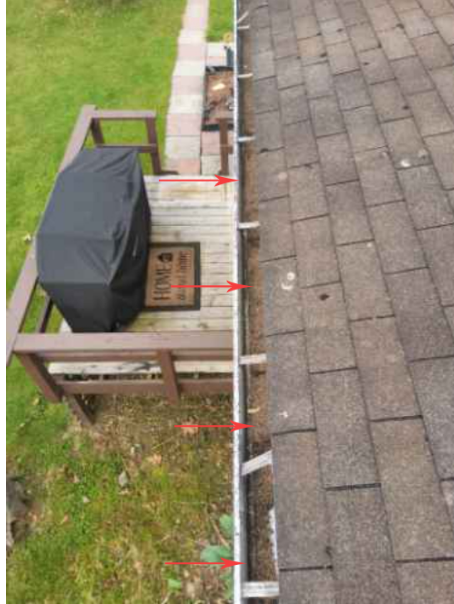
GUTTERS AND DRAINAGE Poor

On the day of inspection it was observed the gutters are filled with excessive granules from the roof covering which could lead to possible water backup and faulty drainage from the roof. Recommend a license general contractor or homeowner clean gutters around the perimeter of the roof.

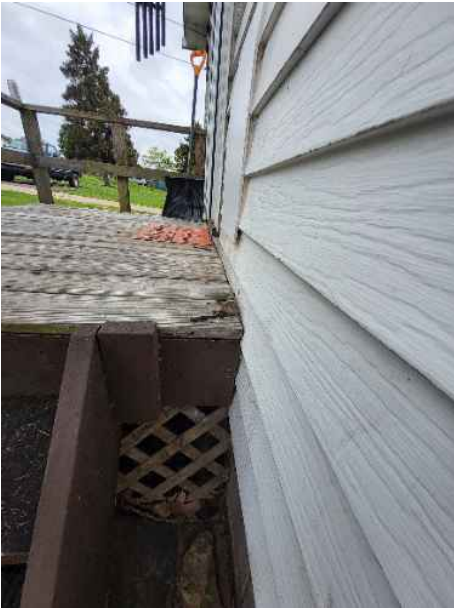
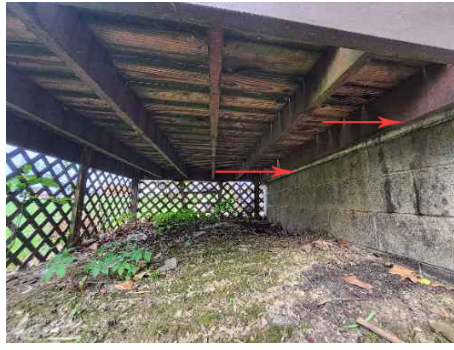
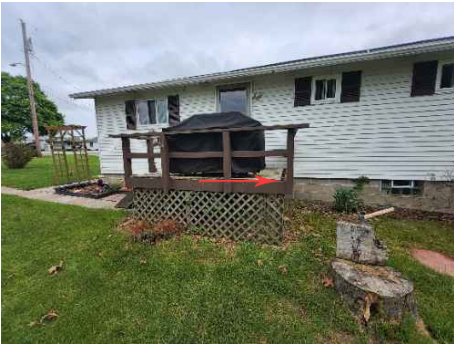
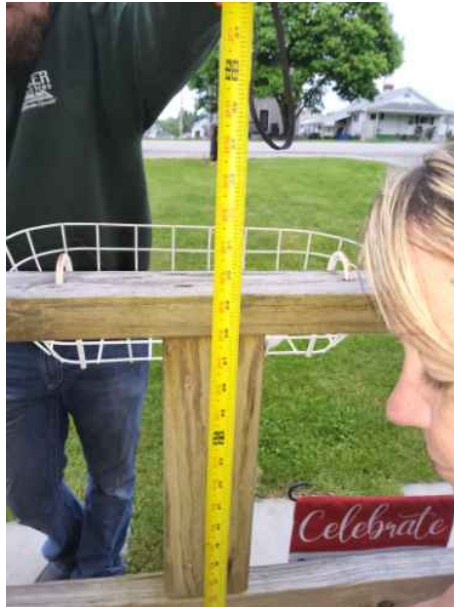
DECKS Poor

At a time of inspection no lag bolts or screws were observed attaching the header board to the deck on the house. Also the side porch deck is missing a board.

Also at the time of inspection the exterior porches / decks had improper railing height, improper guards and no handrails on either set of steps. Though the front deck porch would not require guards or handrails due to the height of the surface of the deck being less than 24 in off the ground but best practice is that railings be installed and at a height of 36 in. Recommend further evaluation and correction by a licensed general contractor or deck company.

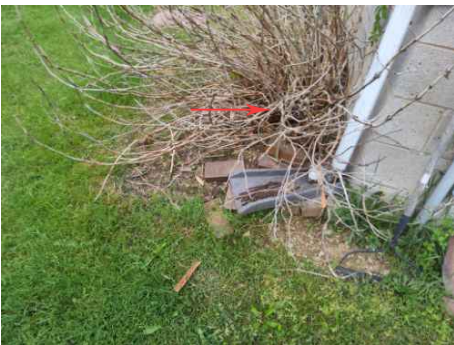
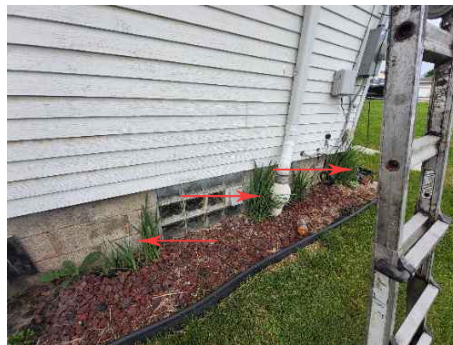
VEGETATION Fair

At the time of inspection some vegetation was observed touching the foundation. This leads to moisture being attracted towards the foundation causing plausible moisture intrusion in the cement block. Recommend further evaluation and correction by a licensed landscaper or homeowner.

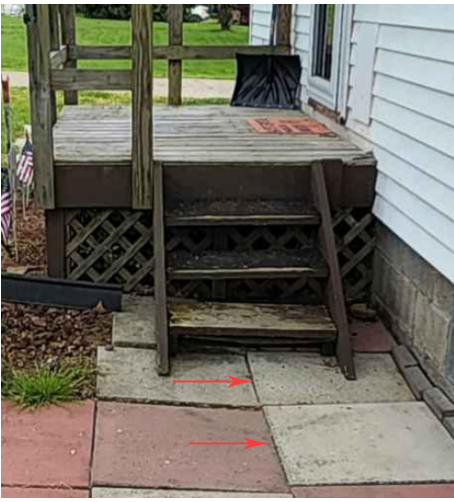
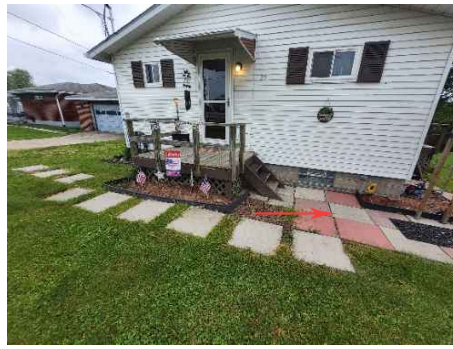
GRADING Fair

Improper grading and or a low spot was observed at the front of the house as depicted by the sinking stepping stones. This could lead to water ponding in that area and seeping down along the foundation causing possible moisture intrusion. Recommend further evaluation and correction by a licensed landscaper or homeowner.

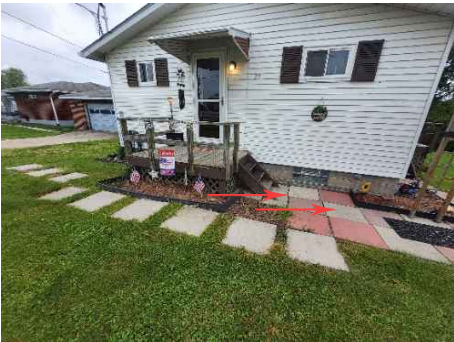
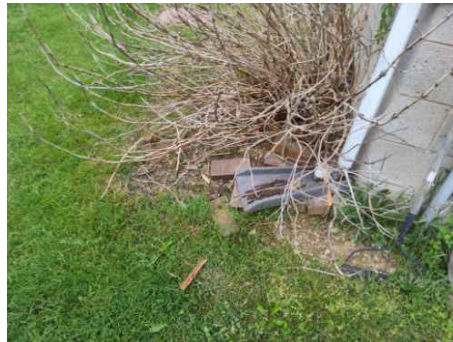
SURFACE DRAINAGE Poor

Again surface drainage and grading in this area of the front of the house is in need of attention to avoid water intrusion into the basement area. In the rear of the house there is a downspout that terminates too close to the foundation, it should terminate at least 5 ft away.

Recommend further evaluation and correction by a licensed landscaper for Homeowner.

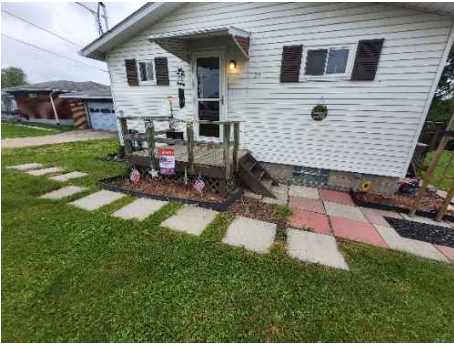
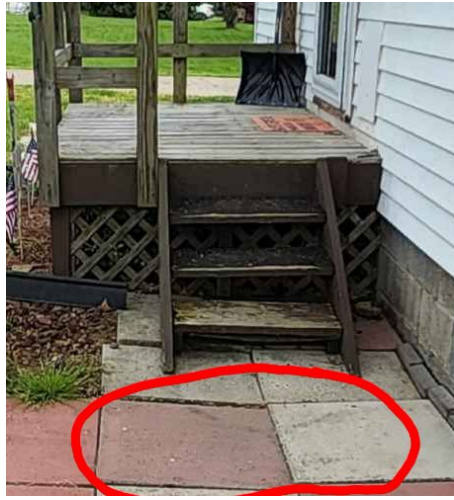
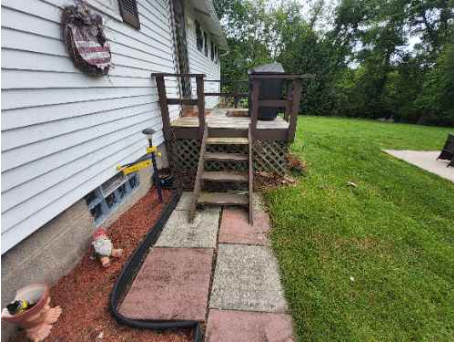
WALKWAYS Fair

On the day of inspection it was observed that the stepping stones near the porch area on the walkway were slightly uneven could pose a possible tripping hazard. Recommend further evaluation and correction by a licensed general contractor or the homeowner.

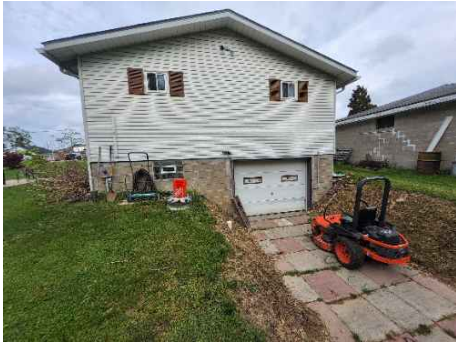
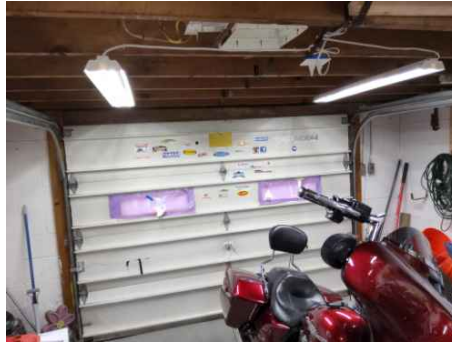
GARAGE DOOR Satisfactory

Garage door is located in the rear of the house and operates satisfactory and manually but appeared to have some cosmetic damage on the exterior which does not affect the functionality of the door.

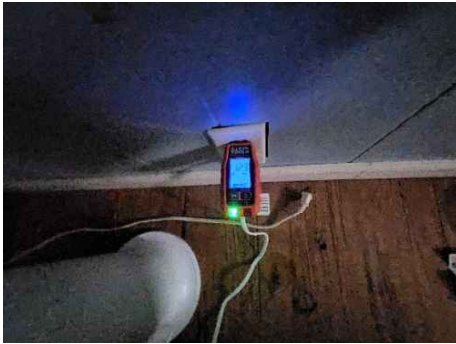
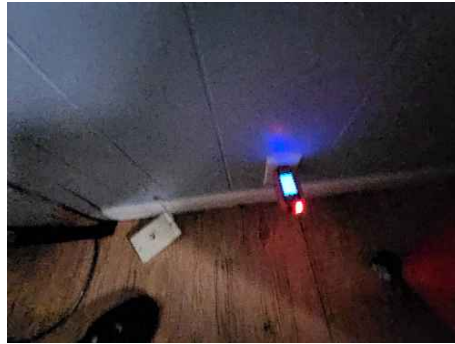
OUTLETS Poor

One of the outlets in this bedroom was observed you not be properly wired with the ground. This poses a potential safety hazard for the occupants. Recommend further evaluation and correction by a license electrician.

One receptacle in bedroom two was not properly grounded. Recommend further evaluation and Corrections by a licensed electrical contractor.

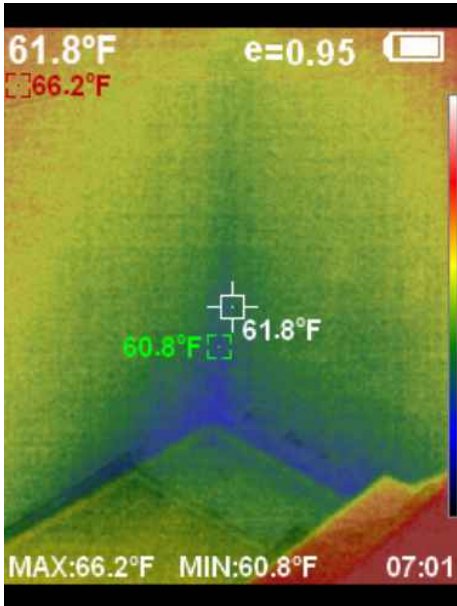
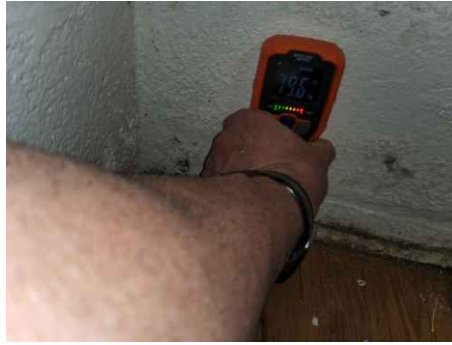
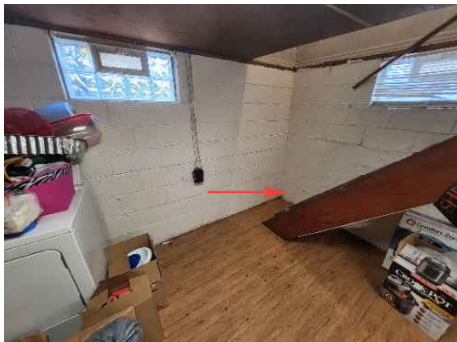
MILDEW PRESENT AT FOUNDATION? No

No mold or mildew was present on the interior wall, but at the time of inspection a thermal image was taken of the interior basement wall showing signs of possible moisture, it was then verified with a moisture meter as a high level. This location is at the bottom of the steps leading from the first floor to the basement. This area is directly below the negative grade landscape by the front porch. Recommend further evaluation by a Basement Waterproofing Company.

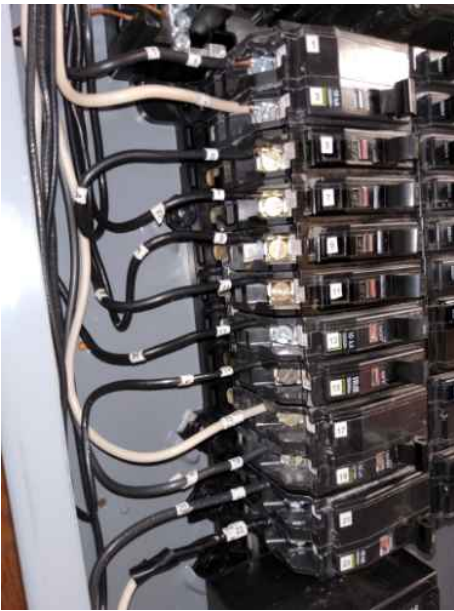
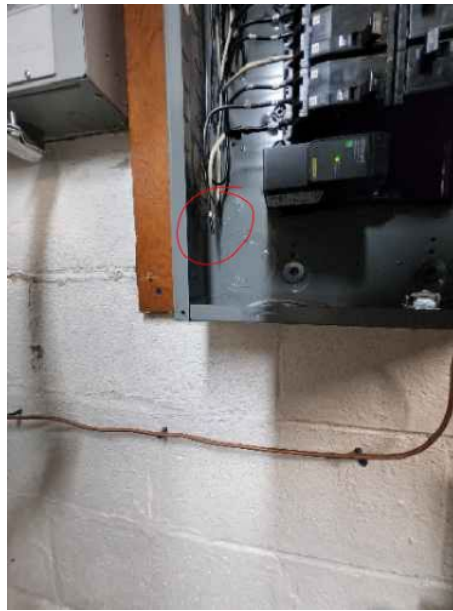
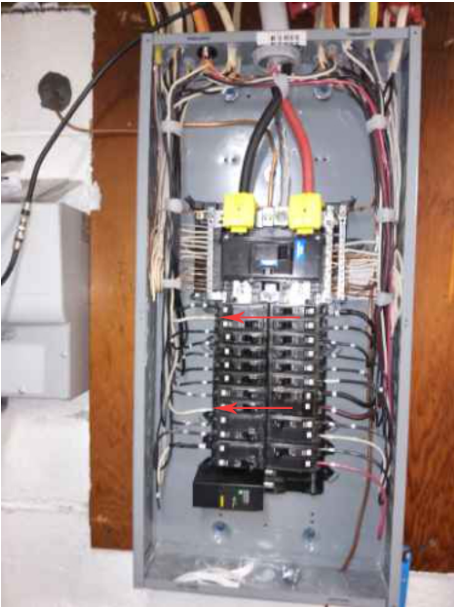
CONDUCTORS Poor

On the day of inspection the dead front cover was removed and it was observed that two locations within the service panel used the white neutral wire as a hot branch circuit wire, those wires should have been marked with black electrical tape to indicate that they are hot wires. (Not neutral) Also there was a branch circuit conductor not connected to a branch circuit interrupter which was found to be the conductor for the the radon mitigation system in the house and the outside receptacles that have no power. Recommend further evaluation and correction by a licensed electrical contractor.

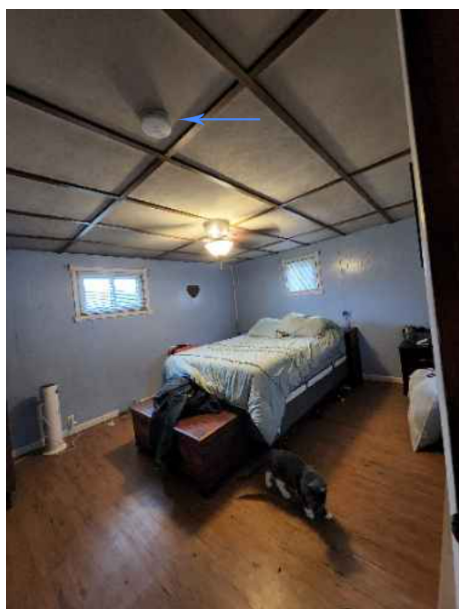
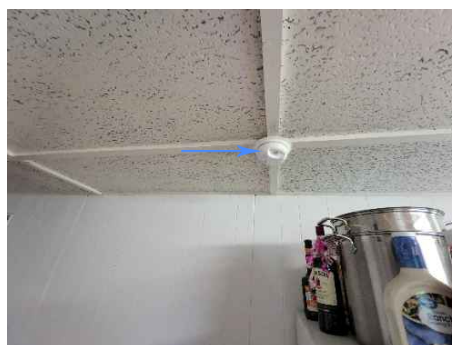
SMOKE ALARM(S) Poor

Only two smoke alarms were located at the time inspection in the home. Recommend smoke alarm be put in the area where the pellet stove is located and the hallway leading to the bedroom.

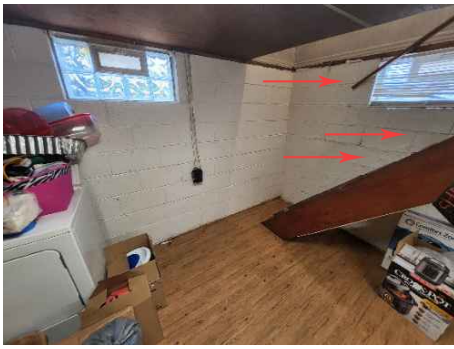
INTERIOR STEPS LEADING TO THE BASEMENT Poor

The interior steps leading to the basement are solid and sturdy but the handrail is too high towards the lower portion of the steps. Also the left side of the stairway should have a baluster or guard to keep from anyone possibly falling off the side of the steps. This poses a significant safety hazard. Recommend further evaluation and correction by a licensed Carpenter or handyman.

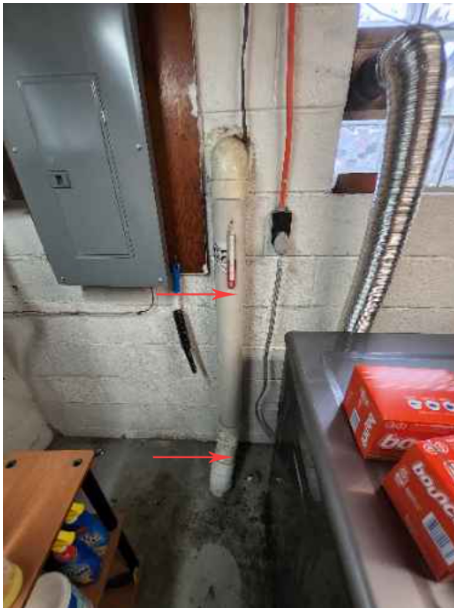
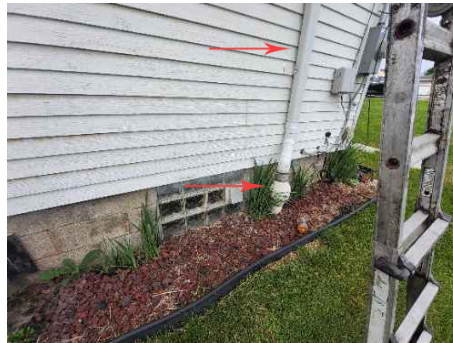
RADON MITIGATION SYSTEM Poor

Located in the basement near the electrical service entrance panel was an active subslab radon mitigation system. During the electrical inspection it was discovered that the branch circuit wiring was not connected to a breaker therefore the radon mitigation system was not off at the time of inspection. This poses a significant health hazard in the home. See the link below for facts on the health hazards of radon. Recommend further evaluation and correction by a license electrical contractor.
