PI Home & Property Inspections

May 16th 2023, 6:01 pm

BUILDING ADDRESS: 123 Sample St.

INSPECTION DESCRIPTION: Residential

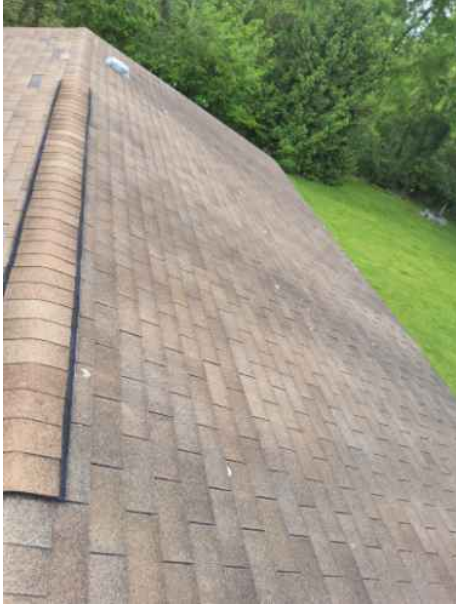
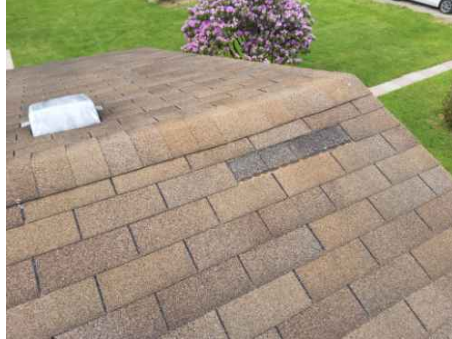
SHINGLES MISSING / DAMAGED? Poor

On the day of inspection it was observed numerous shingles missing from the roof covering leaving exposed nails which will potentially allow moisture penetration into the roof structure. Recommend further evaluation and correction by licensed roofing contractor.

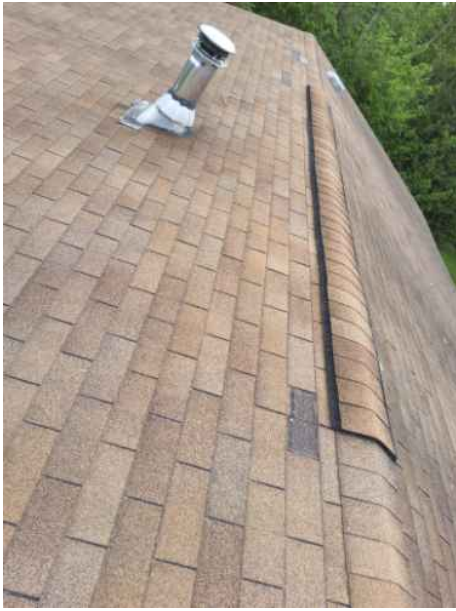
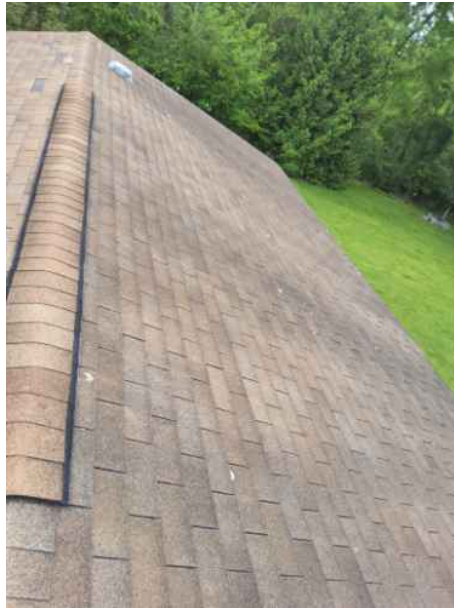
MILDEW PRESENT ON ROOF? No

No mildew or mold or present at the time of inspection on the roof covering.

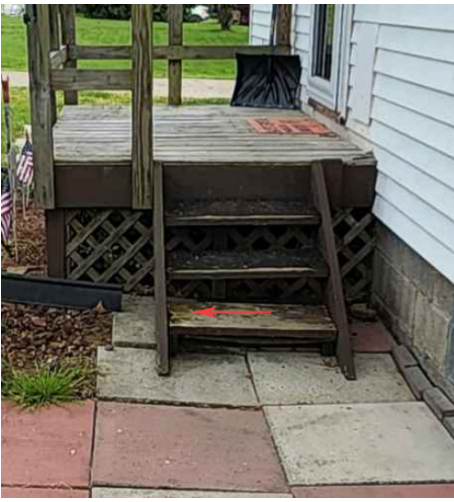
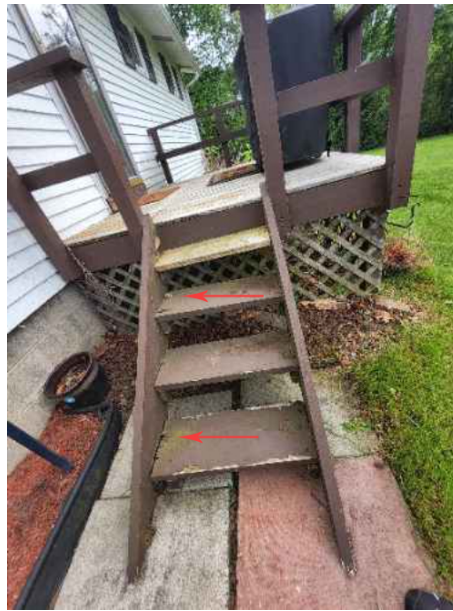
STEPS Poor
Notes:

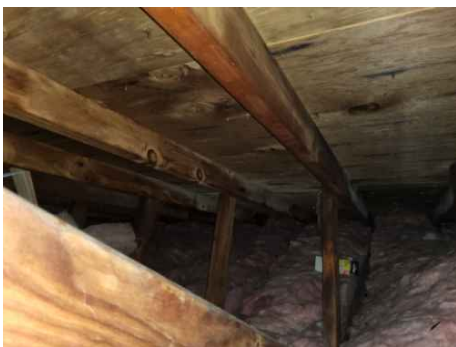
While inspecting the roof and walking around the sheathing was solid and appeared to have no deficiencies or defects at the time of inspection.

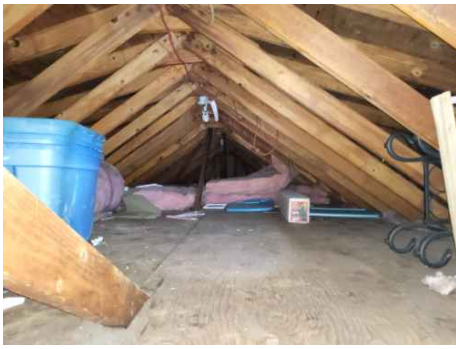
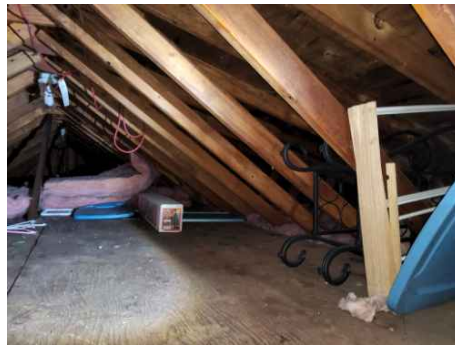
FRAMEWORK Satisfactory

The framework for the roof in the Attic is constructed of trusses.

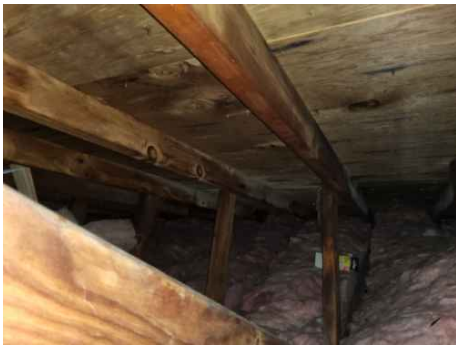
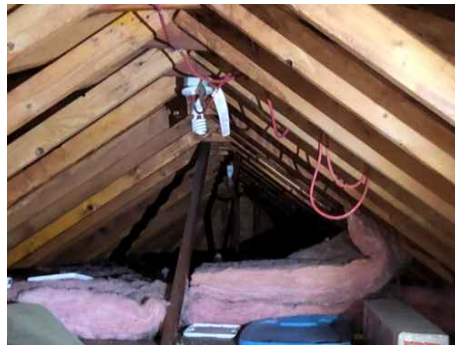
Insulation was observed to be unfaced rolled fiberglass.

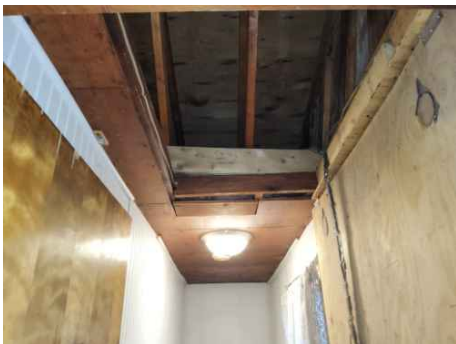
ACCESS Satisfactory

Attic access was located at the top of the steps leading to the basement. There is no pull down ladder to gain access an additional ladder must be used to gain access.

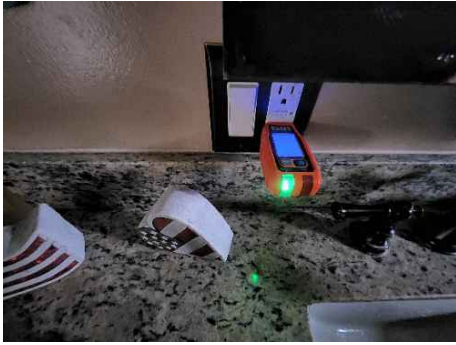
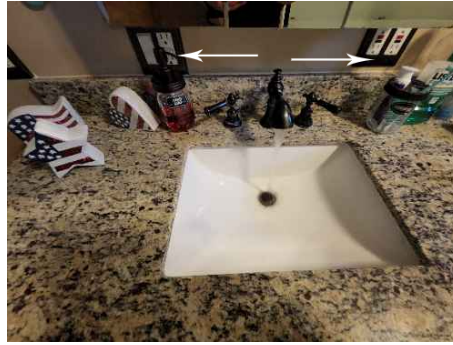
All the outlets on the sink in the bathroom are controlled by the first GFCI outlet and found to be wired and working properly at the time of inspection.

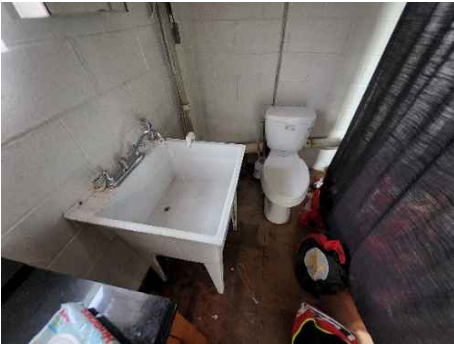
WALLS Satisfactory

The lower basement bathroom is unfinished and walls are constructed of foundation block.

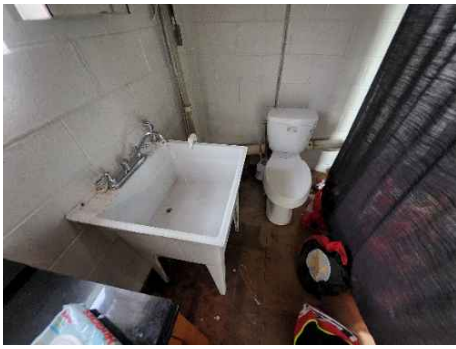
Sink located in the basement bathroom is of a washtub style.

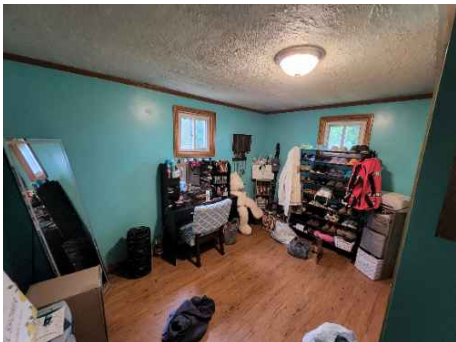
FLOORING Satisfactory

Floors installed in this bedroom are of hardwood.

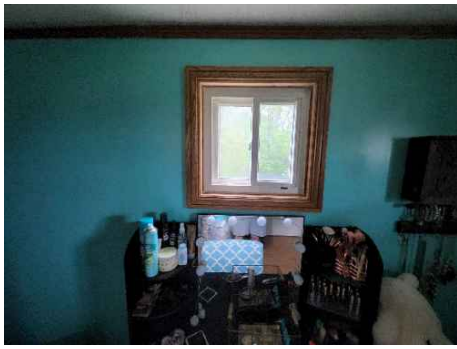
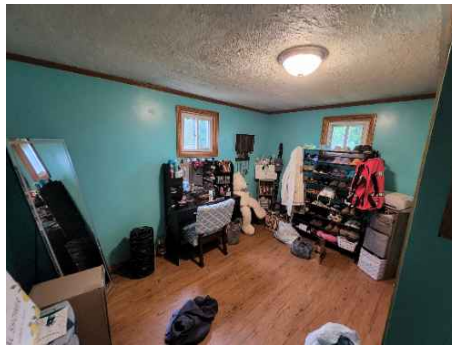
Newer vinyl windows are installed.

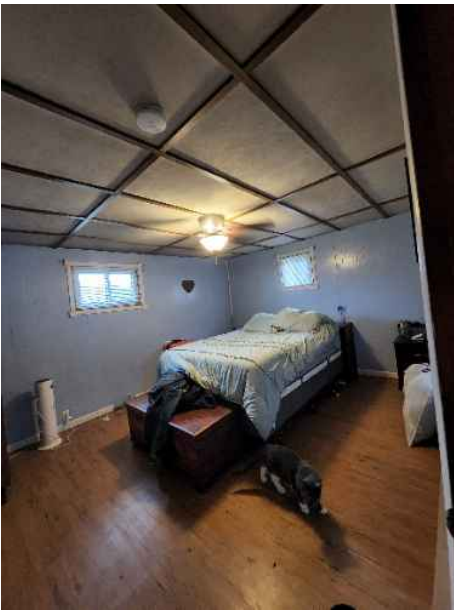
Flooring in this bedroom is of hardwood material.

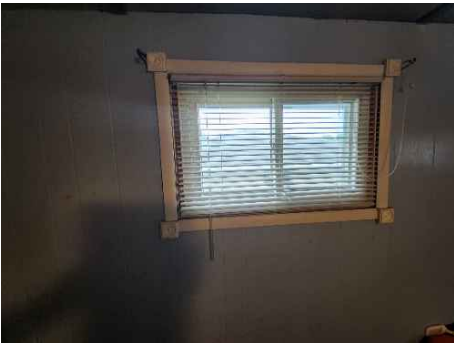
Windows in this bedroom we're observed to be a newer vinyl sliding window.

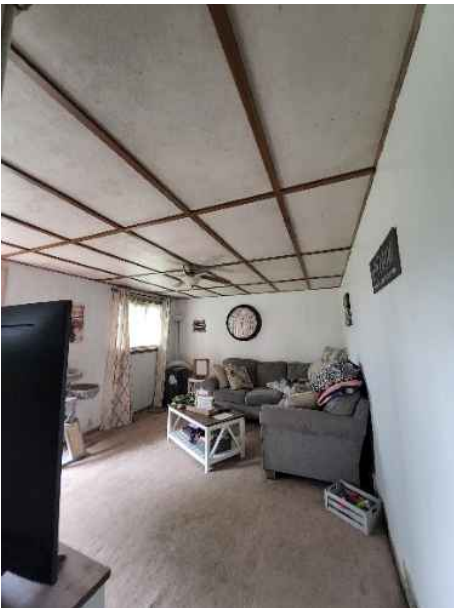
Flooring was wall to wall carpet.

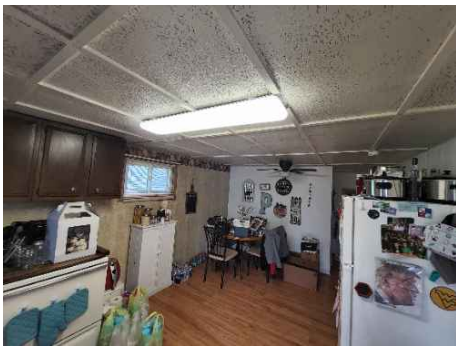
Flooring in the kitchen is Hardwood.

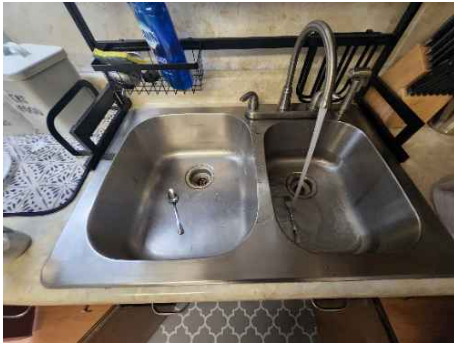
There was no garbage disposal observed as being installed in the kitchen at the time of inspection.

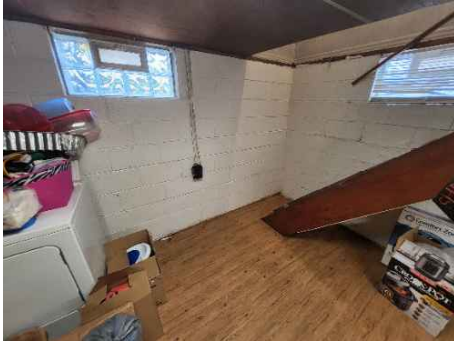
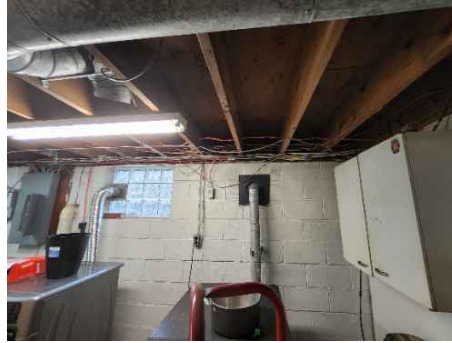
Masonry block Foundation.

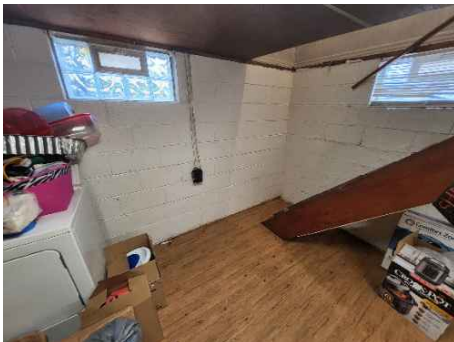
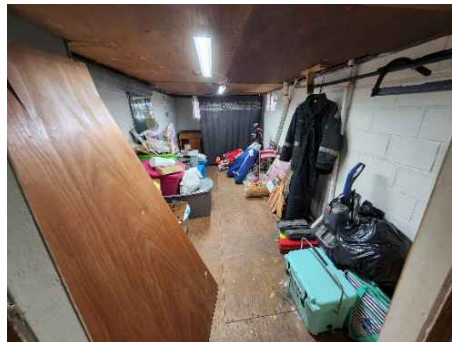
Basement foundation slab was not inspected because it is covered with a wood type laminate flooring. Only portion not covered was area of laundry room and the garage.

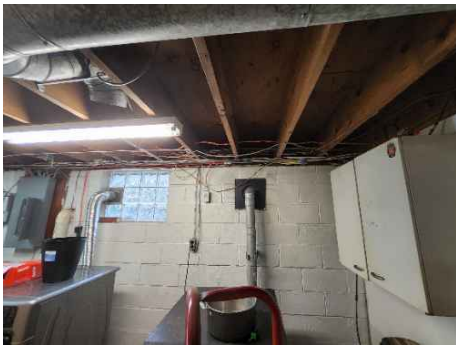
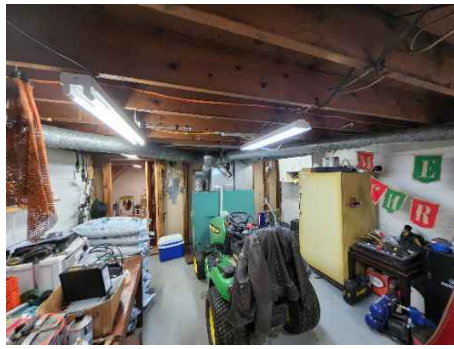
Foundation walls appear to have no defects or deficiencies at the time of inspection.

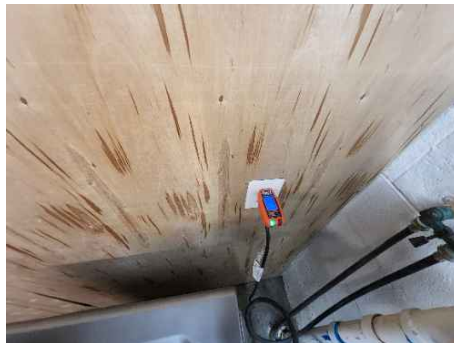
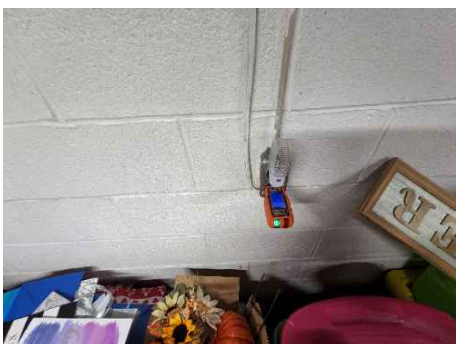
All basement outlets tested good and were operable at the time of inspection.

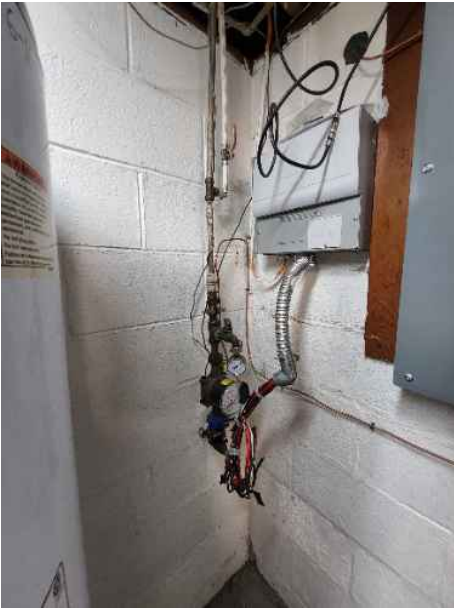
The location of the main water supply shuttle valve is located between the hot water tank and the service entrance panel on the wall with the meter.

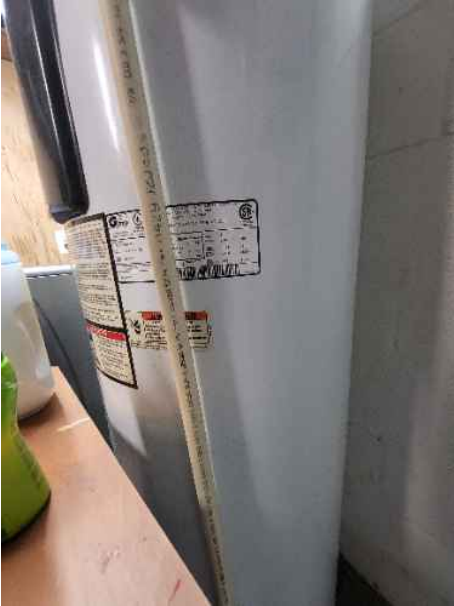
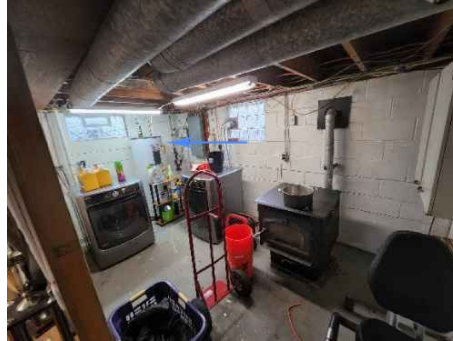
The water heater is a 50 gallon capacity and of electrical source, the TPR valve was properly installed.

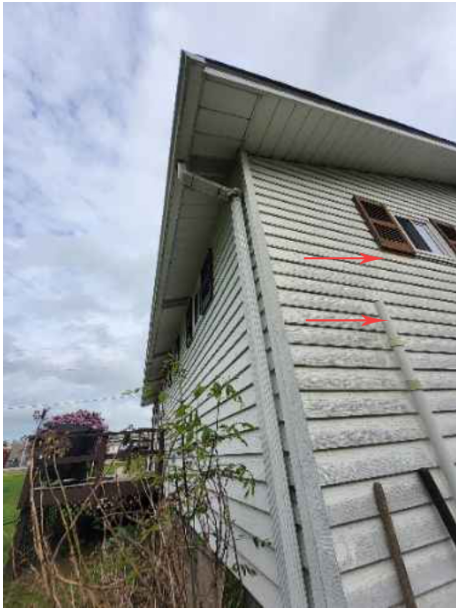
The plumbing vent system is located at the rear of the house it terminates not for from a window. The standard for vent termination is 4 ft below an operable window this appears to be within that deviation but best practice is to have the vent terminate above the roof line.

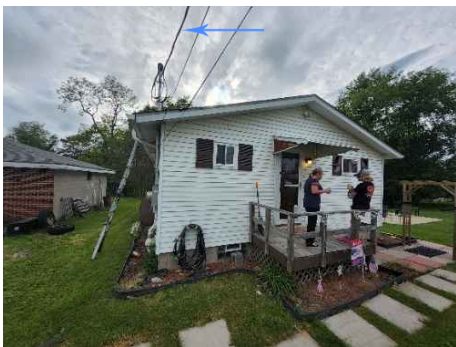
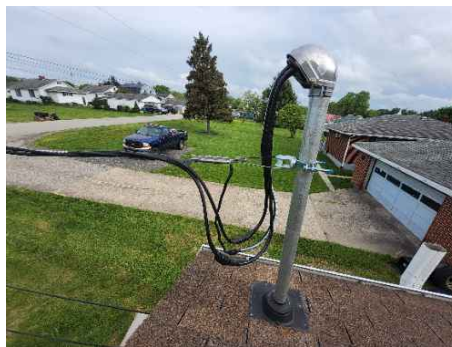
The service head gooseneck and drip loops were properly installed.
The service mast was properly attached to the house.
The electric meter is rated for a 200 amp service.

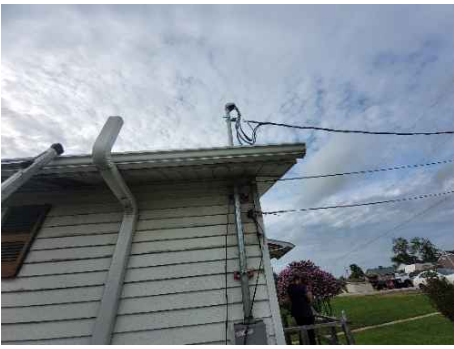
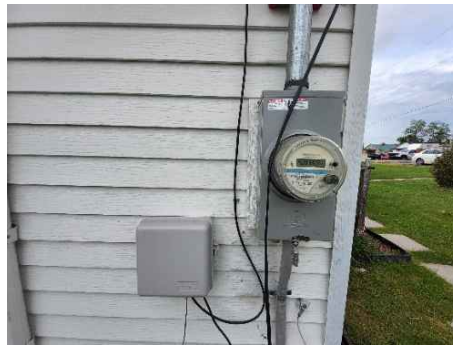
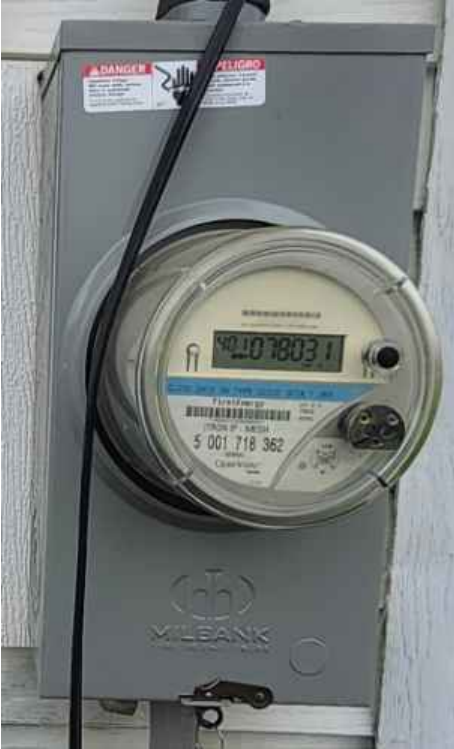
On the day of inspection the dead front cover was removed and it was observed that two locations within the service panel used the white neutral wire as a hot branch circuit wire, those wires should have been marked with black electrical tape to indicate that they are hot wires. (Not neutral) Also there was a branch circuit conductor not connected to a branch circuit interrupter which was found to be the conductor for the the radon mitigation system in the house and the outside receptacles that have no power. Recommend further evaluation and correction by a licensed electrical contractor.

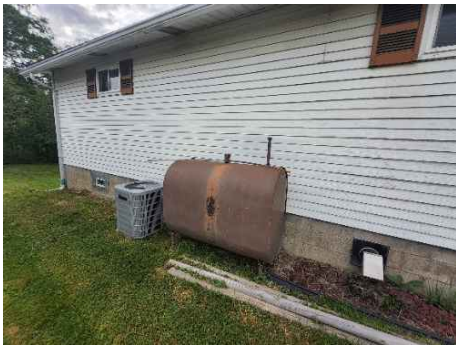
The heating energy source is fuel oil and the cooling energy source is electricity. Also in the basement is a pellet stove. The fuel oil storage tank is located above ground on the left side of the house next to the air conditioner compressor unit.

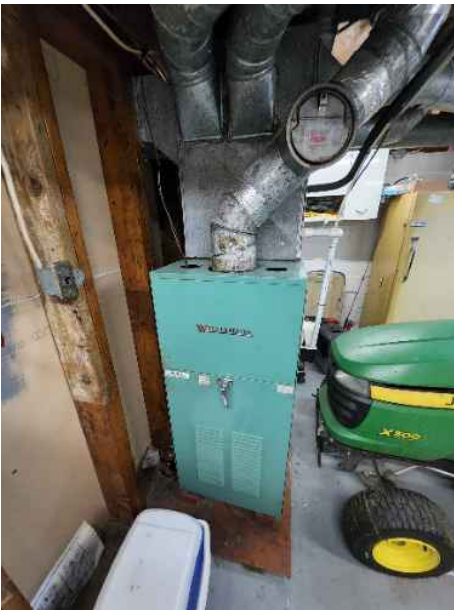
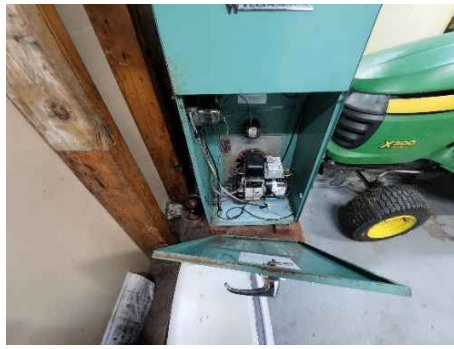
Primary source of heating is fuel oil forced air furnace that is located in the garage. Also there is a secondary heating source located in the area of the laundry room that is a pellet stove. The manufacturer's tag on the fuel oil furnace was not legible at the time of inspection.

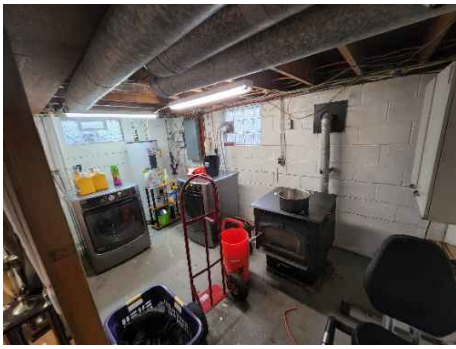
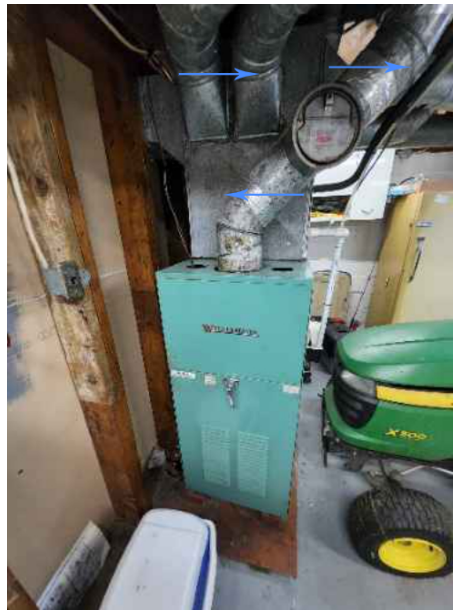
Forced air duct system is the heating method.

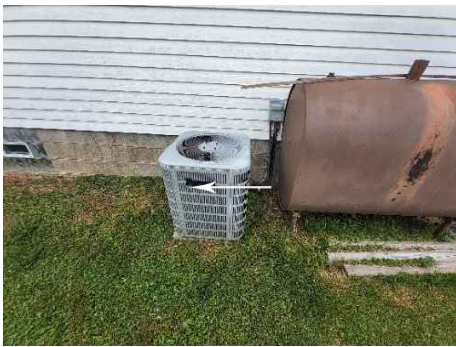
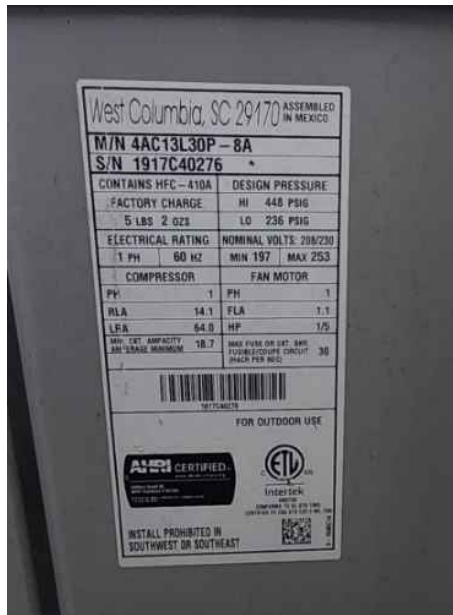
The cooling method is a central air split system.

The cooling system was not tested or inspected because on the day of inspection the ambient temperature was below 65° Fahrenheit this creates an unsafe condition on the cooling unit itself . Recommend testing and annual maintenance prior to operating the cooling system when the weather gets warmer.

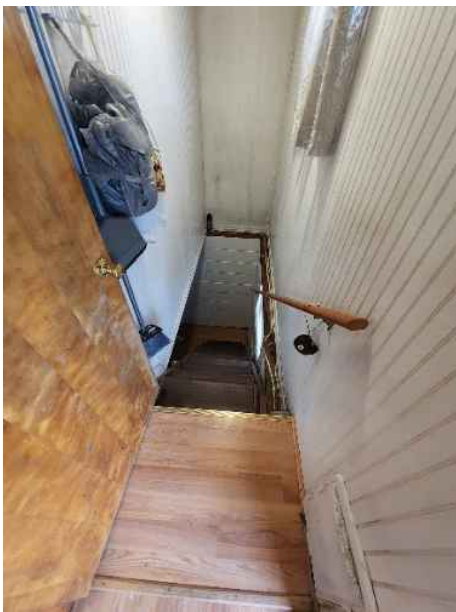
As you enter the house through the front door the access to the lower level basement area is directly to your right through a doorway and down a set of steps.

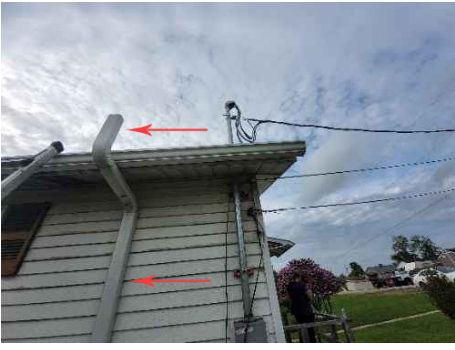
Located in the basement near the electrical service entrance panel was an active subslab radon mitigation system. During the electrical inspection it was discovered that the branch circuit wiring was not connected to a breaker therefore the radon mitigation system was not off at the time of inspection. This poses a significant health hazard in the home. See the link below for facts on the health hazards of radon. Recommend further evaluation and correction by a license electrical contractor.
